# Addendum

DEMOLITION OF MOBILE KITCHEN

## Addendum 04

# **Asbestos, Lead-Based Paint & Universal Regulated Waste Survey Report**

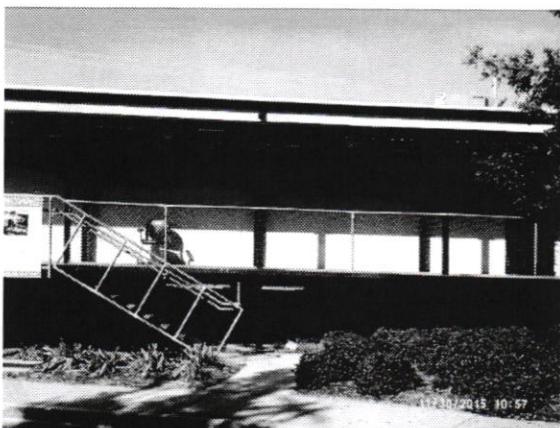
**Photo #1** Exterior view of dental clinic building

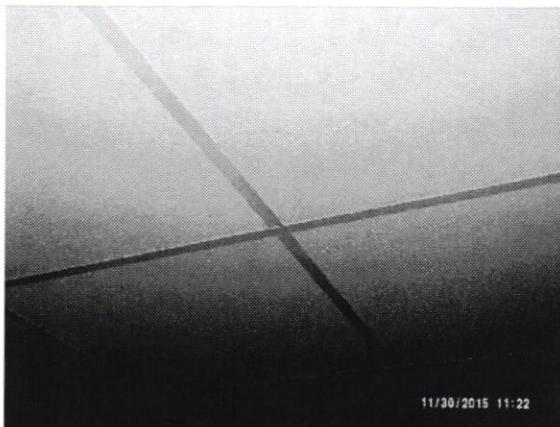
**Photo #2** View of HA No. 01 – 2'x2' worm/pinhole ceiling tile located in the dental clinic (ND)

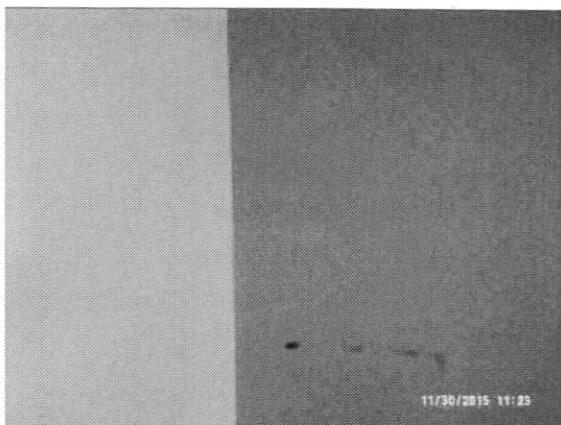
**Photo #3** View of HA No. 02 – drywall walls with associated joint compound located in the dental clinic (ND)

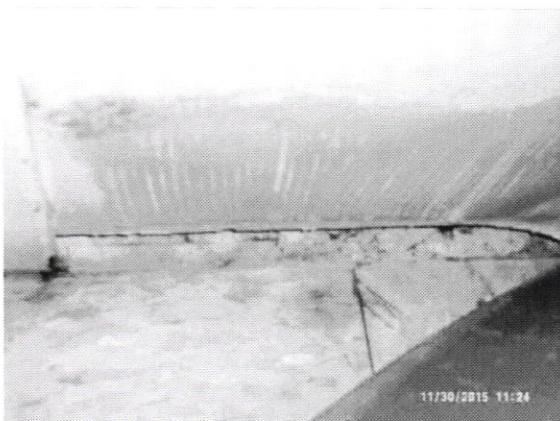
**Photo #4** View of HA No. 03 – cove base adhesive located in the dental clinic (ND)

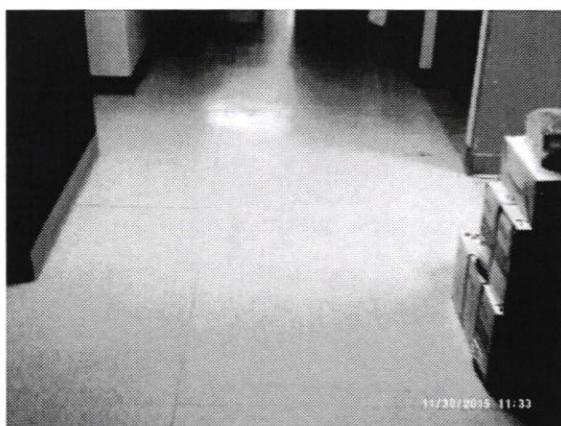
**Photo #5** View of HA No. 04 – 12"x12" floor tile with yellow glue located in the dental clinic (ND)

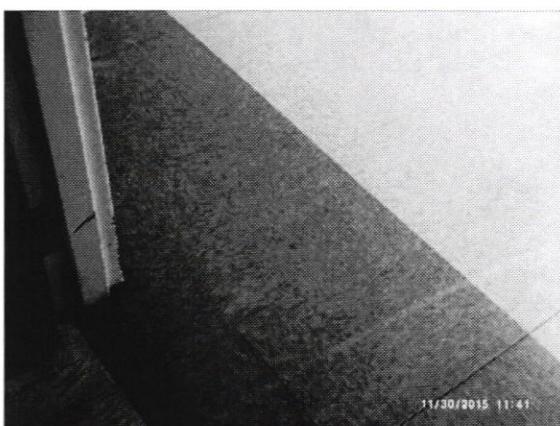
**Photo #6** View of HA No. 05 – 12"x12" blue floor tile with yellow glue located in the dental clinic (ND)

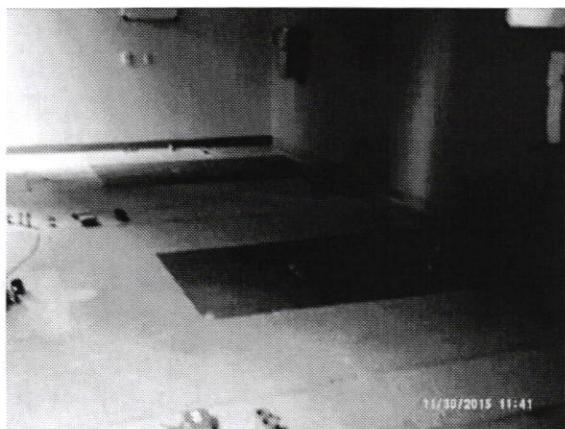
**Photo #7** View of HA No. 06 – 12"x12" brown floor tile with yellow glue located in the dental clinic (ND)

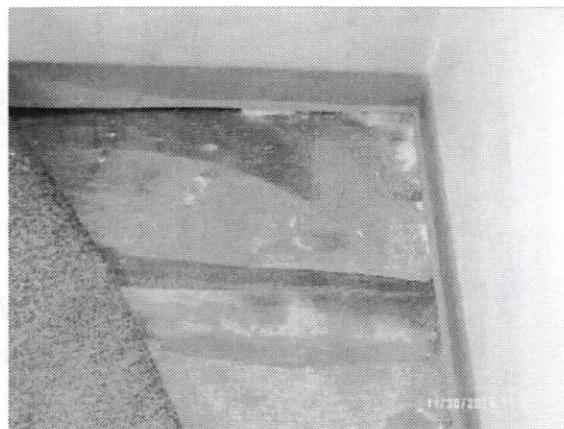
**Photo #8** View of HA No. 07 – yellow carpet glue located in meeting rooms of the dental clinic (ND)

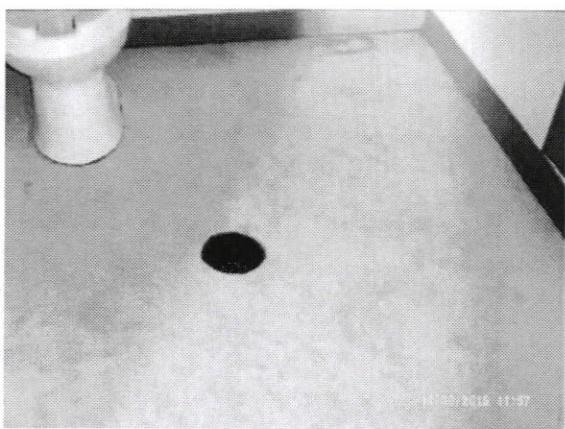
**Photo #9** View of HA No. 08 – laminate flooring located in the restrooms of the dental clinic (ND)

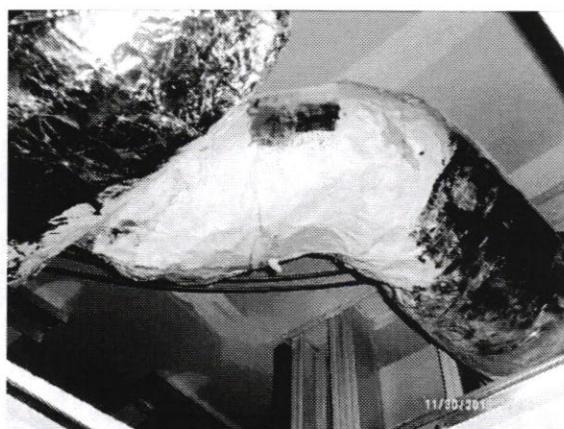
**Photo #10** View of HA No. 09 – HVAC duct wrap with associated mastic located above the ceiling deck in the dental clinic (ND)

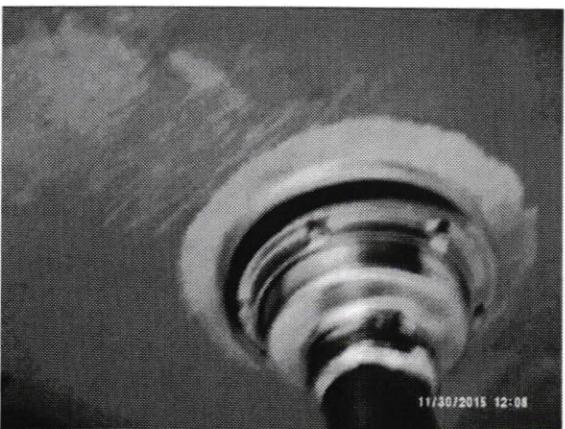
**Photo #11** View of HA No. 10 – sink undercoating in the dental clinic (ND)

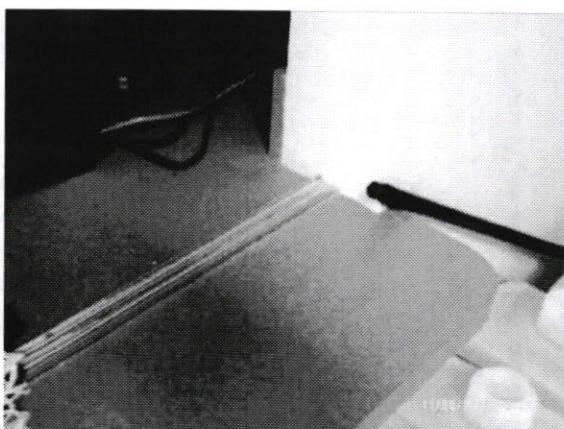
**Photo #12** View of HA No. 11 – laminate countertops in the dental clinic (ND)

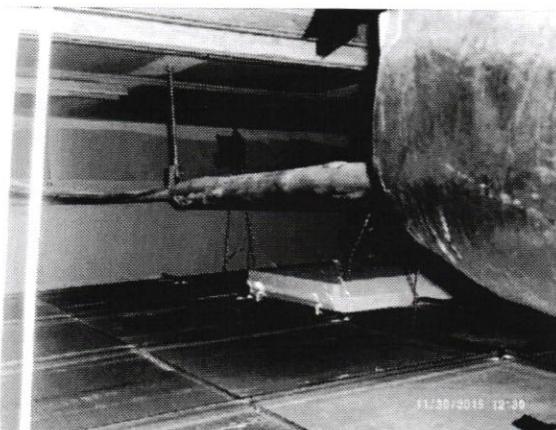
**Photo #13** View of HA No. 12 – black insulation on the water pipes located above the ceiling deck of the dental clinic (ND)

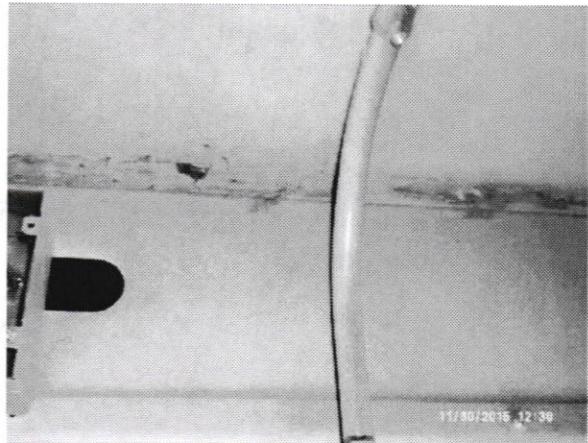
**Photo #14** View of HA No. 13 – fire stop caulk located above the ceiling deck in the dental clinic (ND)

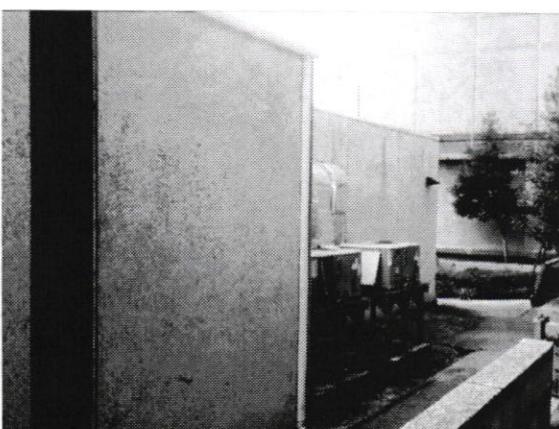
**Photo #15** View of exterior of pharmacy building

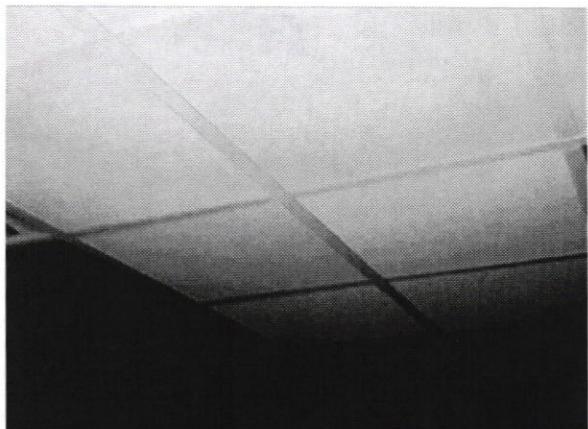
**Photo #16** View of HA No. 14 – texture ceiling tile located in the IV lab of the pharmacy building (ND)

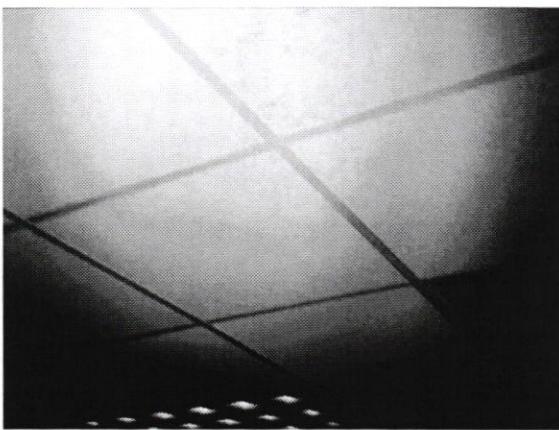
**Photo #17** View of HA No. 15 – 2'x2' worm/pinhole ceiling tile located in the pharmacy building (ND)

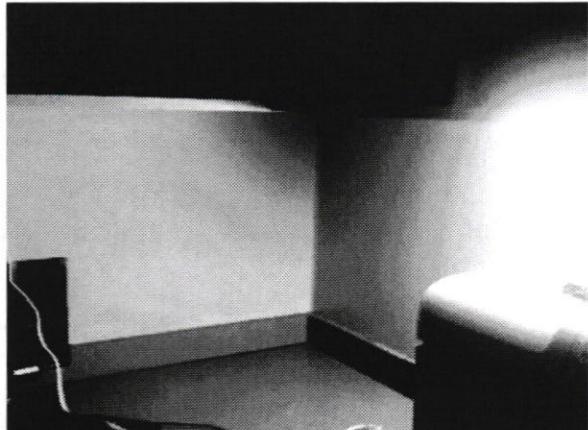
**Photo #18** View of HA No. 16 – drywall walls with associated joint compound located in the pharmacy building (ND)

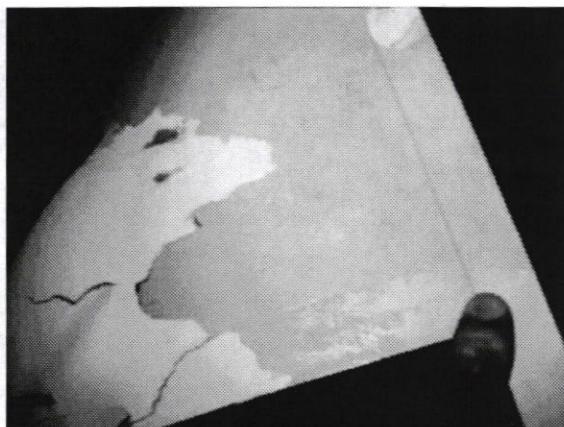
**Photo #19** View of HA No. 17 – Clear mastic behind the Fiber Reinforced plastic wainscot located in the pharmacy building (ND)

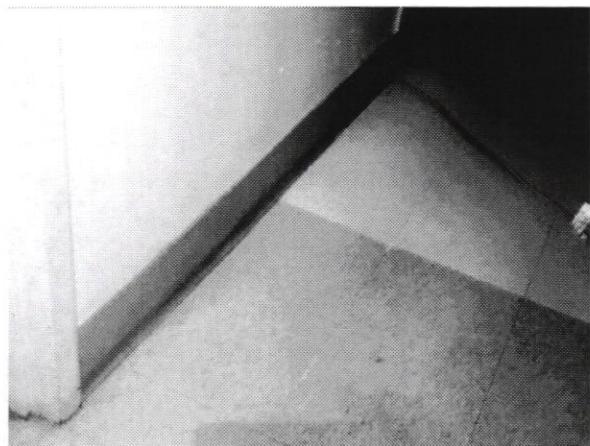
**Photo #20** View of HA No. 18 – cove base adhesive located in the pharmacy building (ND)

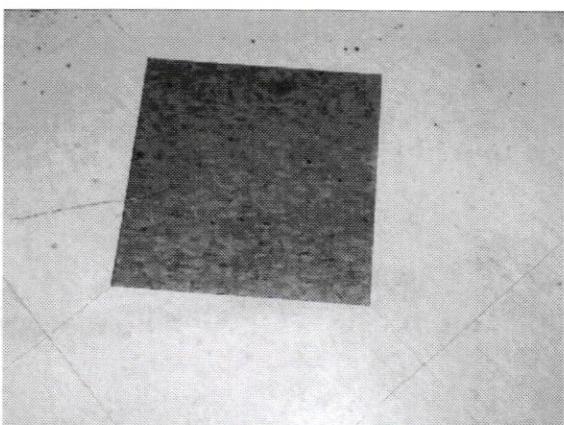
**Photo #23** View of HA No. 21 – 12"x12" blue floor tile with yellow glue located in the pharmacy building (ND)

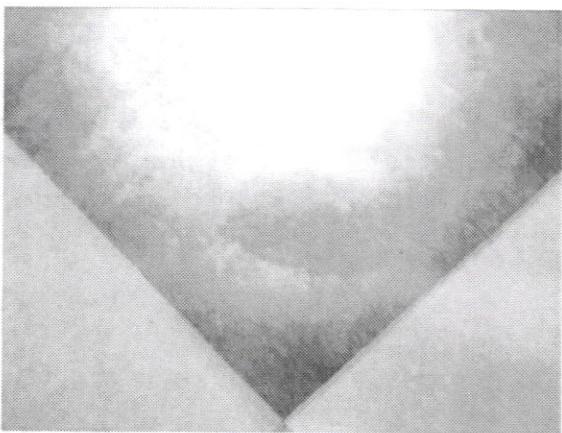
**Photo #25** View of HA No. 23 – 12"x12" dark brown floor tile with yellow glue located in the pharmacy building (ND)

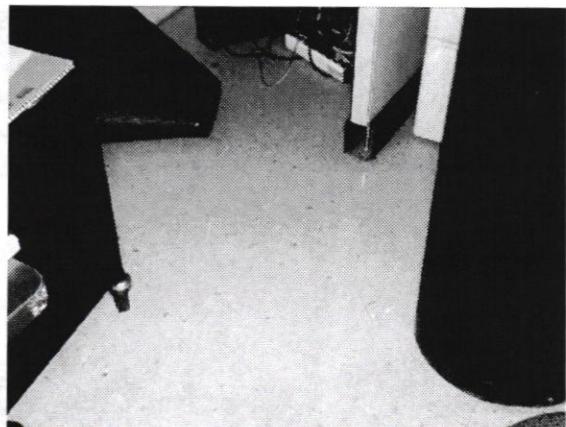
**Photo #26** View of HA No. 24 – 12"x12" white streak floor tile with yellow glue located in the pharmacy building (ND)

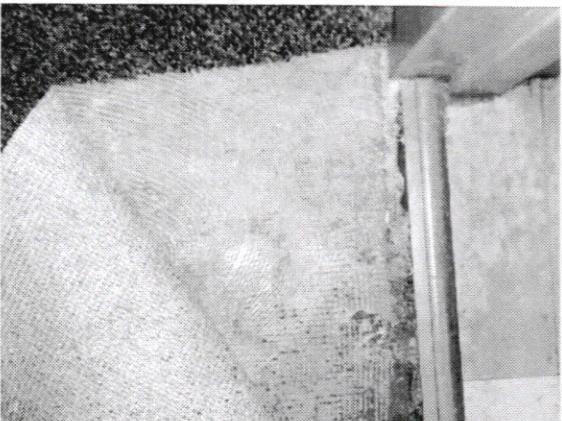
**Photo #27** View of HA No. 25 – yellow carpet glue located in the pharmacy building (ND)

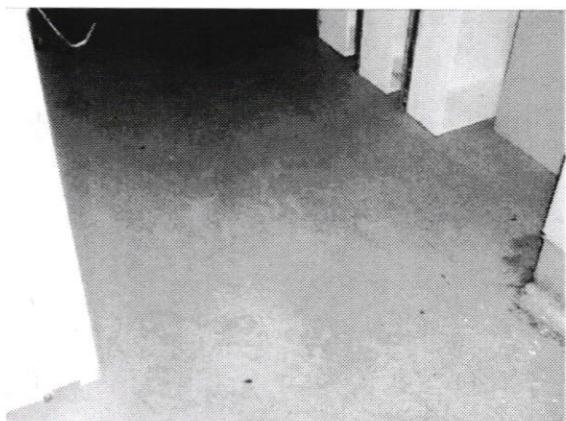
**Photo #28** View of HA No. 26 – rubberized flooring with glue located in the IV lab of the pharmacy building (ND)

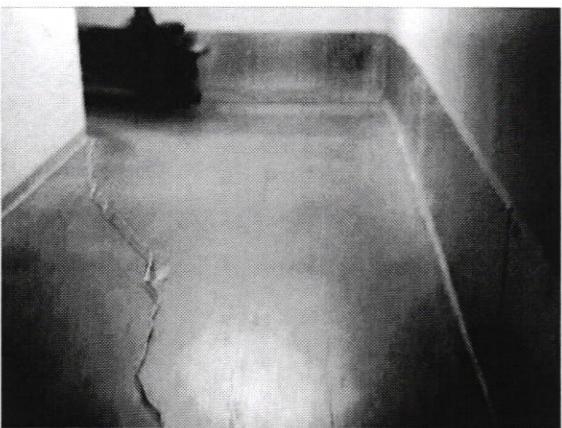
**Photo #29** View of HA No. 27 – flooring from the walkway to the pharmacy building (ND)

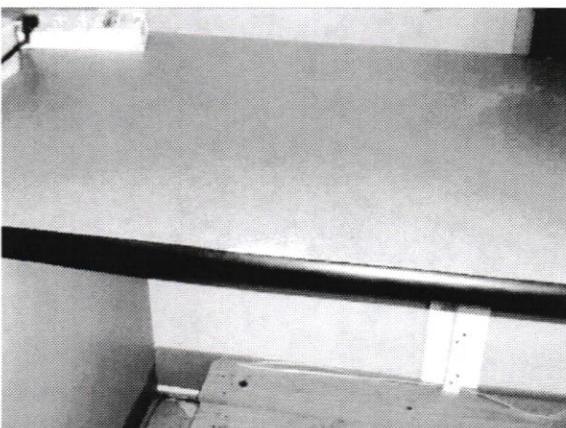
**Photo #30** View of HA No. 28 – laminate counter tops with adhesive located in the pharmacy building (ND)

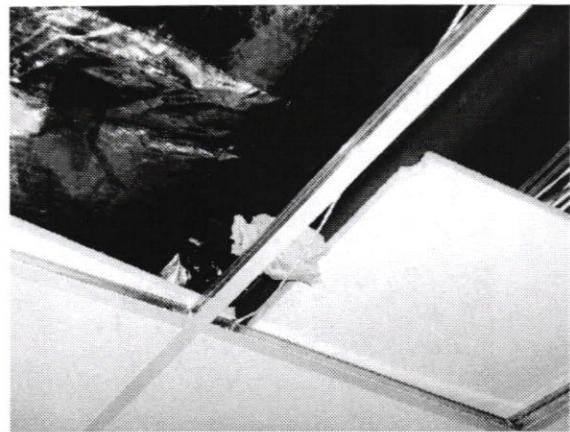
**Photo #32** View of HA No. 30 – HVAC duct insulation located above the ceiling deck in the pharmacy building (ND)

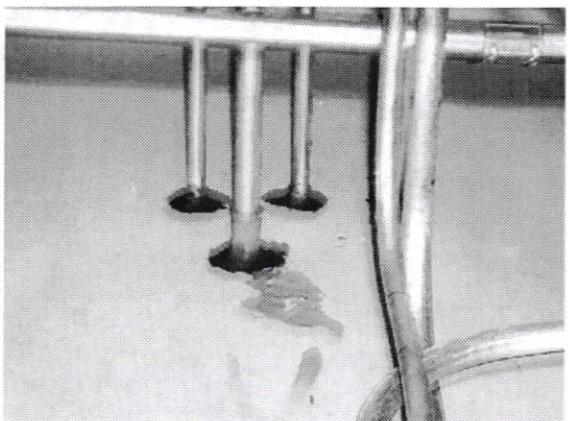
**Photo #33** View of HA No. 31 – fire stop caulk located above the ceiling deck in the pharmacy building (ND)

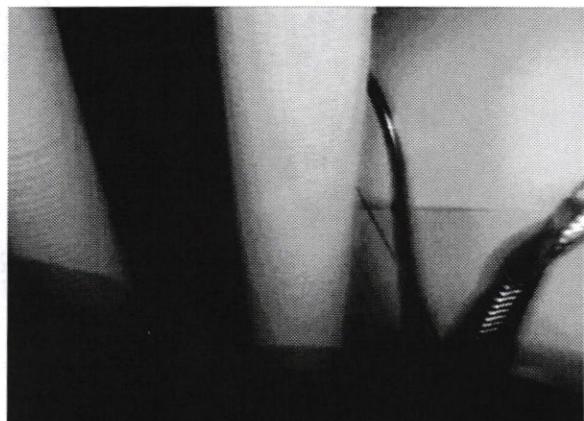
**Photo #34** View of HA No. 32 – pipe insulation wrap located on pipes above the ceiling deck in the pharmacy building (ND)

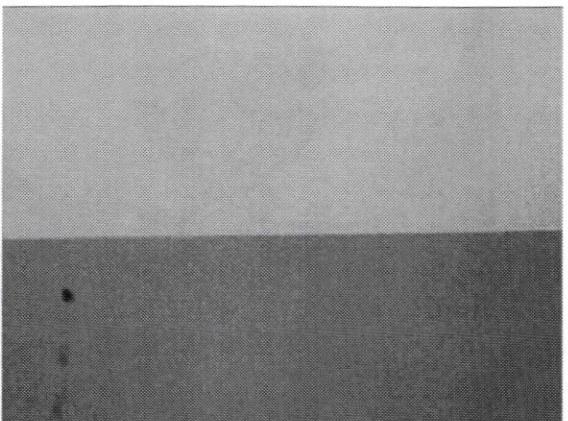
**Photo #35** View of HA No. 33 – drywall ceiling with associated joint compound located in the pharmacy building (ND)

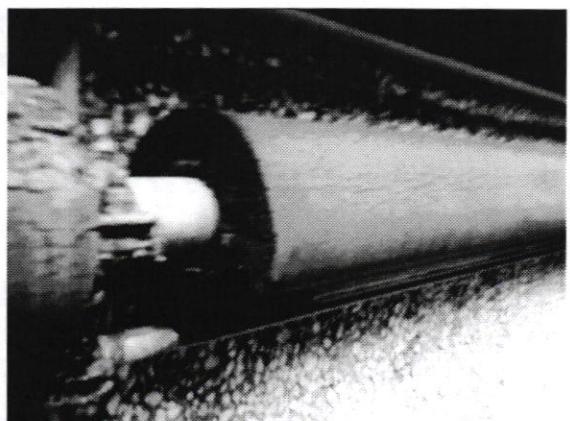
**Photo #36** View of HA No. 34 – exterior pipe insulation on HVAC unit of the pharmacy building (ND)

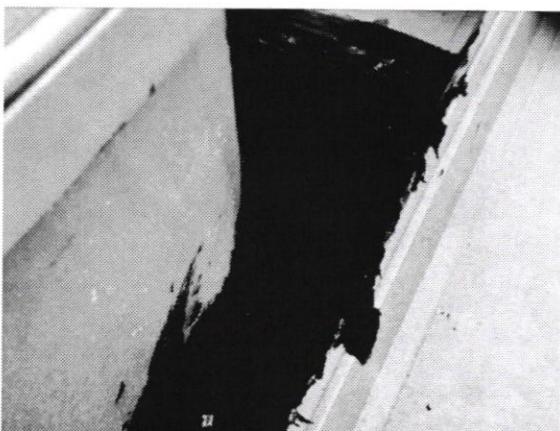
**Photo #37** View of HA No. 35 – vent flashing on the roof of the pharmacy building (ND)

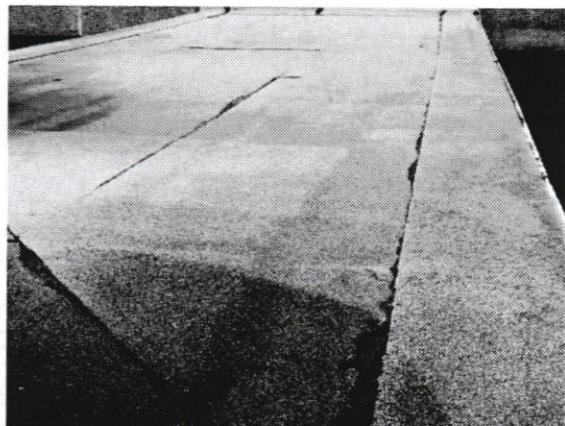
**Photo #38** View of HA No. 36 – pitch tar roof located on the walkway leading to the pharmacy building (ND)

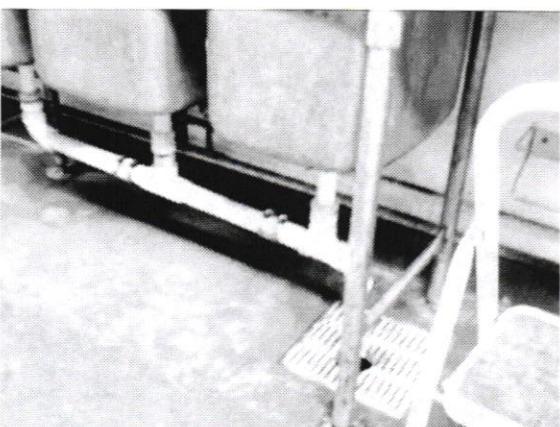
**Photo #39** View of HA No. 01 – rubber floor glue located in the kitchen extension of the pharmacy building (ND)

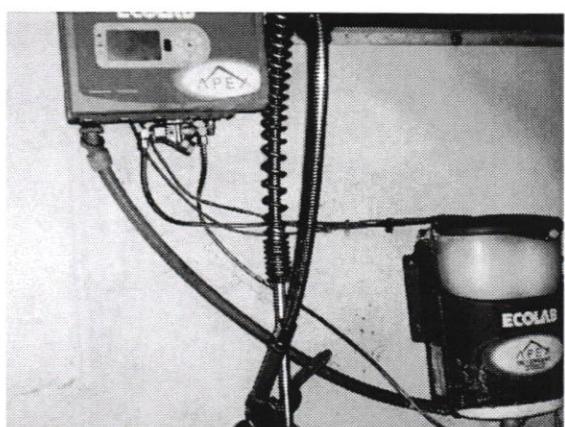
**Photo #40** View of HA No. 02 – fiber re-enforced panel mastic on walls of kitchen extension of the pharmacy building (ND)

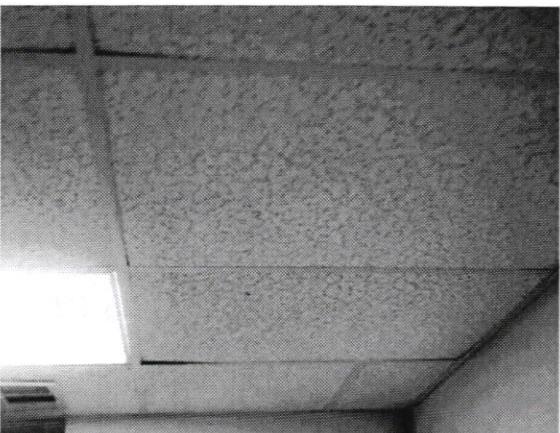
**Photo #41** View of HA No. 03 – 2'x4' worm/pinhole ceiling tile in the kitchen extension of the pharmacy building (ND)

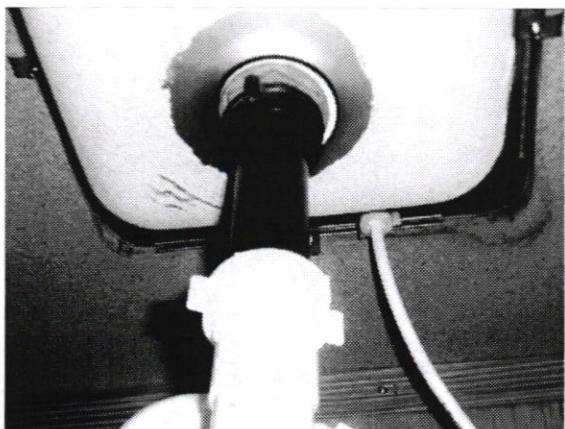
**Photo #42** View of HA No. 04 – Sink undercoating in the kitchen extension of the pharmacy building (ND)

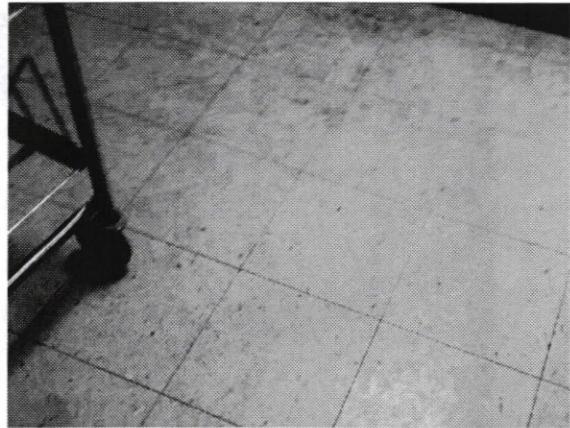
**Photo #43** View of HA No. 05 – 12"x12" grey floor tile with yellow glue located in the kitchen extension of the pharmacy building (ND)

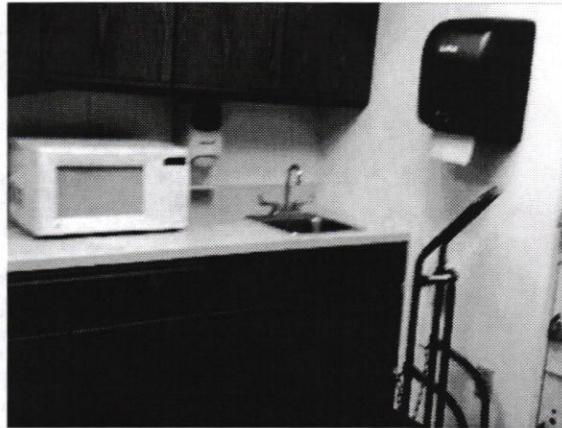
**Photo #44** View of HA No. 06 – laminate countertops with associated glue located in the kitchen extension of the pharmacy building (ND)

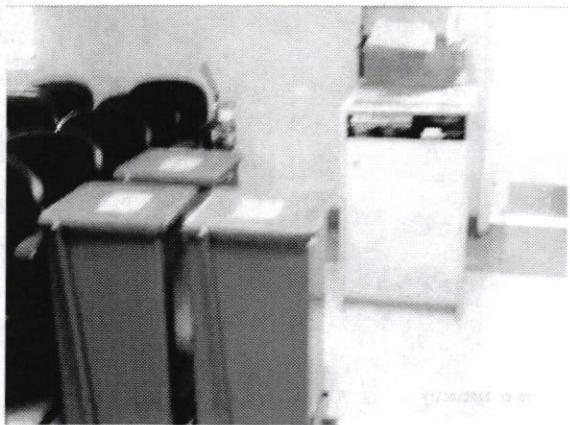
**Photo #45** View of various hazardous waste trash cans located in the dental clinic

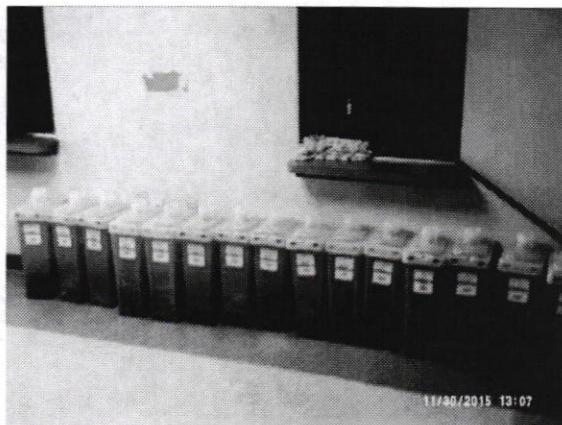
**Photo #46** View of sharps containers located in the dental clinic

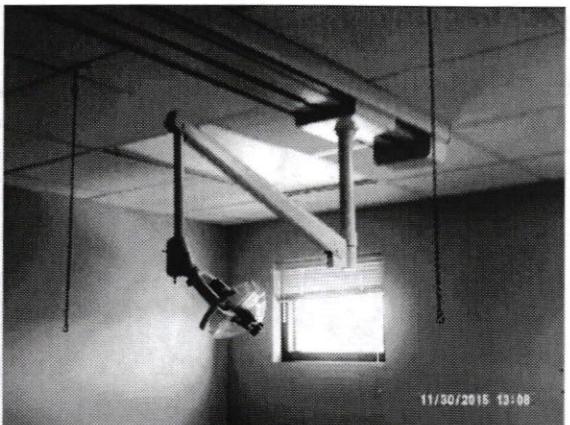
**Photo #47** View of surgical lights which may contain mercury in the dental clinic

Terracon recommends the materials identified in Table 1 above be handled properly and disposed of accordingly in a facility that treats, disposes of or recycles universal waste.

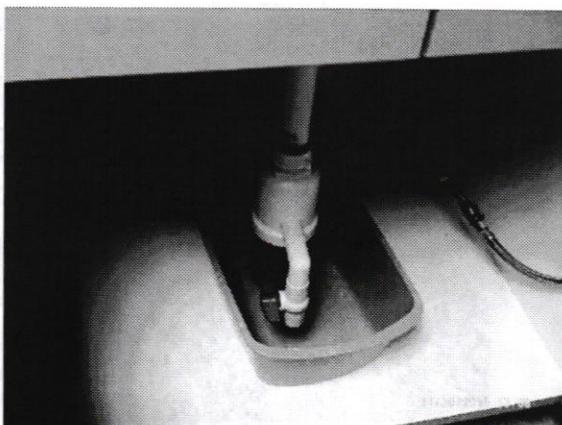
**Photo #48** View of sink traps in the dental clinic laboratory area

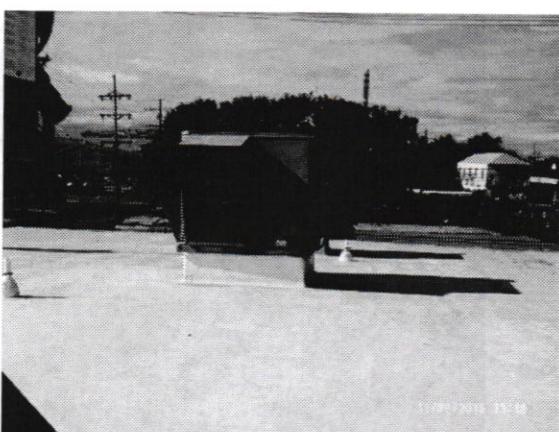
**Photo #49** View of HVAC with R-410A refrigerant on top of dental clinic roof

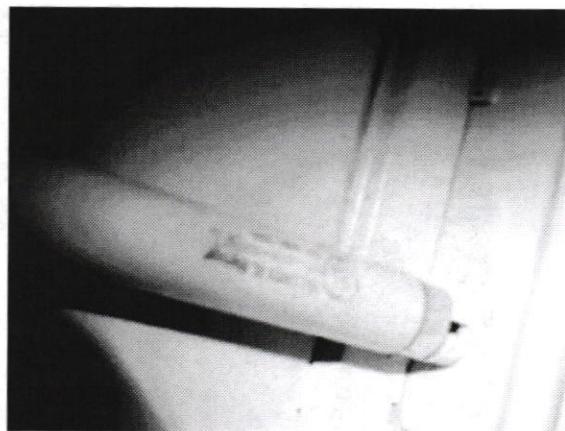
**Photo #50** View of an example of Mercury containing fluorescent light bulbs in both the dental and pharmacy building

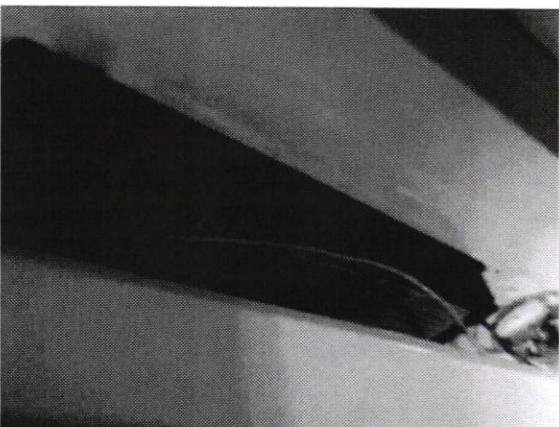
**Photo #51** View of PCB containing fluorescent light ballast in both the dental and pharmacy building

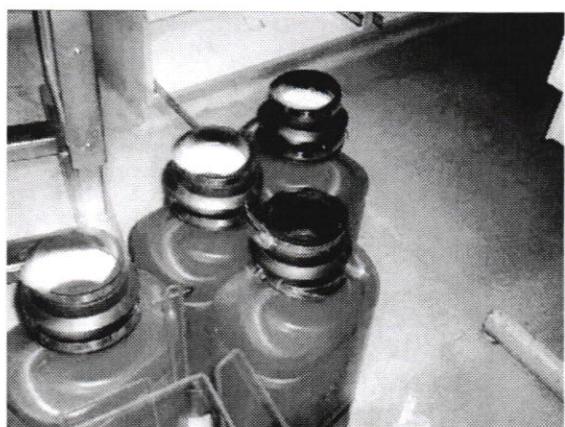
**Photo #52** View of various sharps containers located in pharmacy building

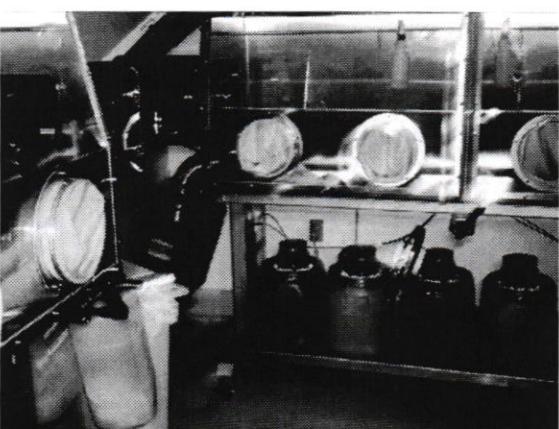
**Photo #53** View of various medical waste containers located in pharmacy building

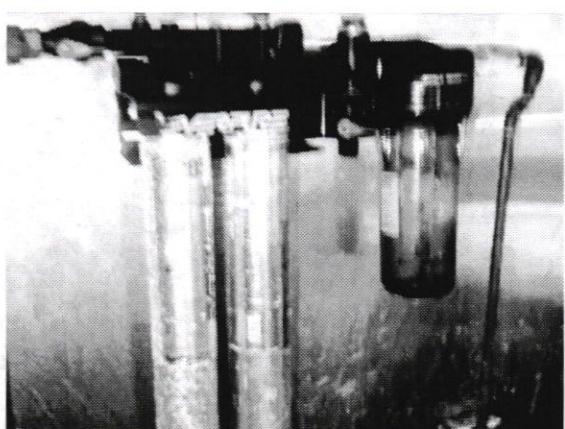
**Photo #54** View of sink traps in the kitchen extension of the pharmacy building

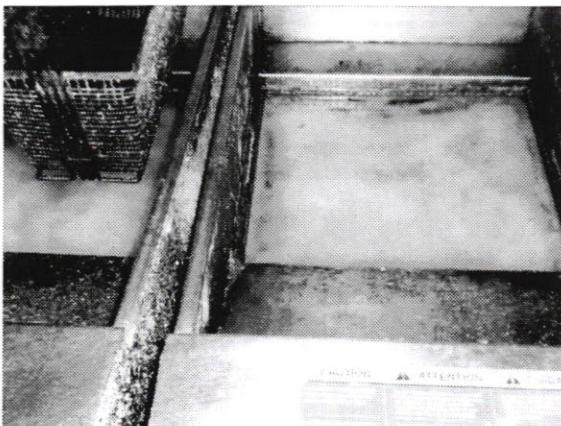
**Photo #55** View of grease in fryers in the kitchen extension of the pharmacy building

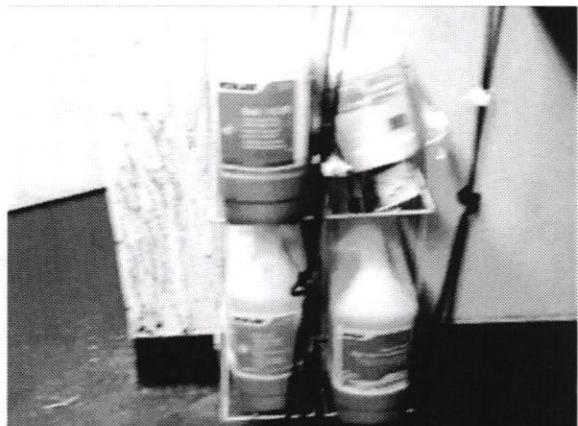
**Photo #56** View of sanitization chemicals still present in the kitchen extension of the pharmacy building

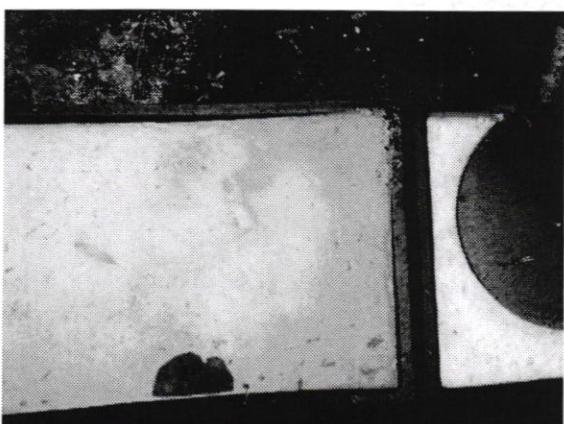
**Photo #57** View of grease storage dumpster outside the kitchen extension of the pharmacy building

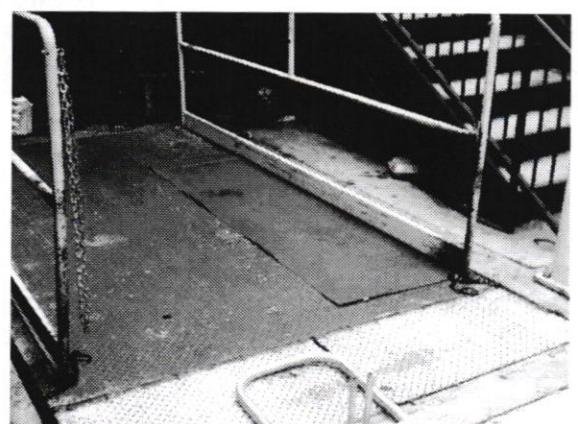
**Photo #58** View of hydraulic lift located outside the kitchen extension of the pharmacy building

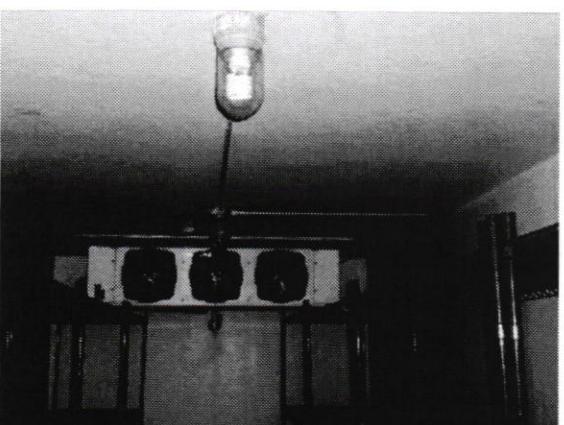
**Photo #59** View of refrigerant containing motors for walk in freezer for kitchen extension of the pharmacy building

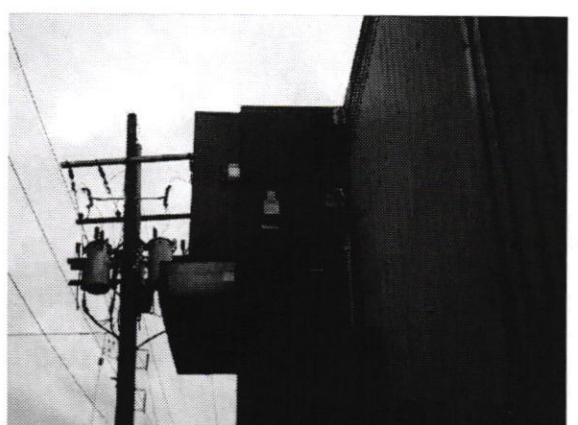
**Photo #60** View of refrigerant containing HVAC unit for kitchen extension of pharmacy building
